< Reference > July 5, 2012 Tokyo Electric Power Company

"Development of Remote Decontamination Technology" Result of Unit 2-3 Reactor Building Investigation

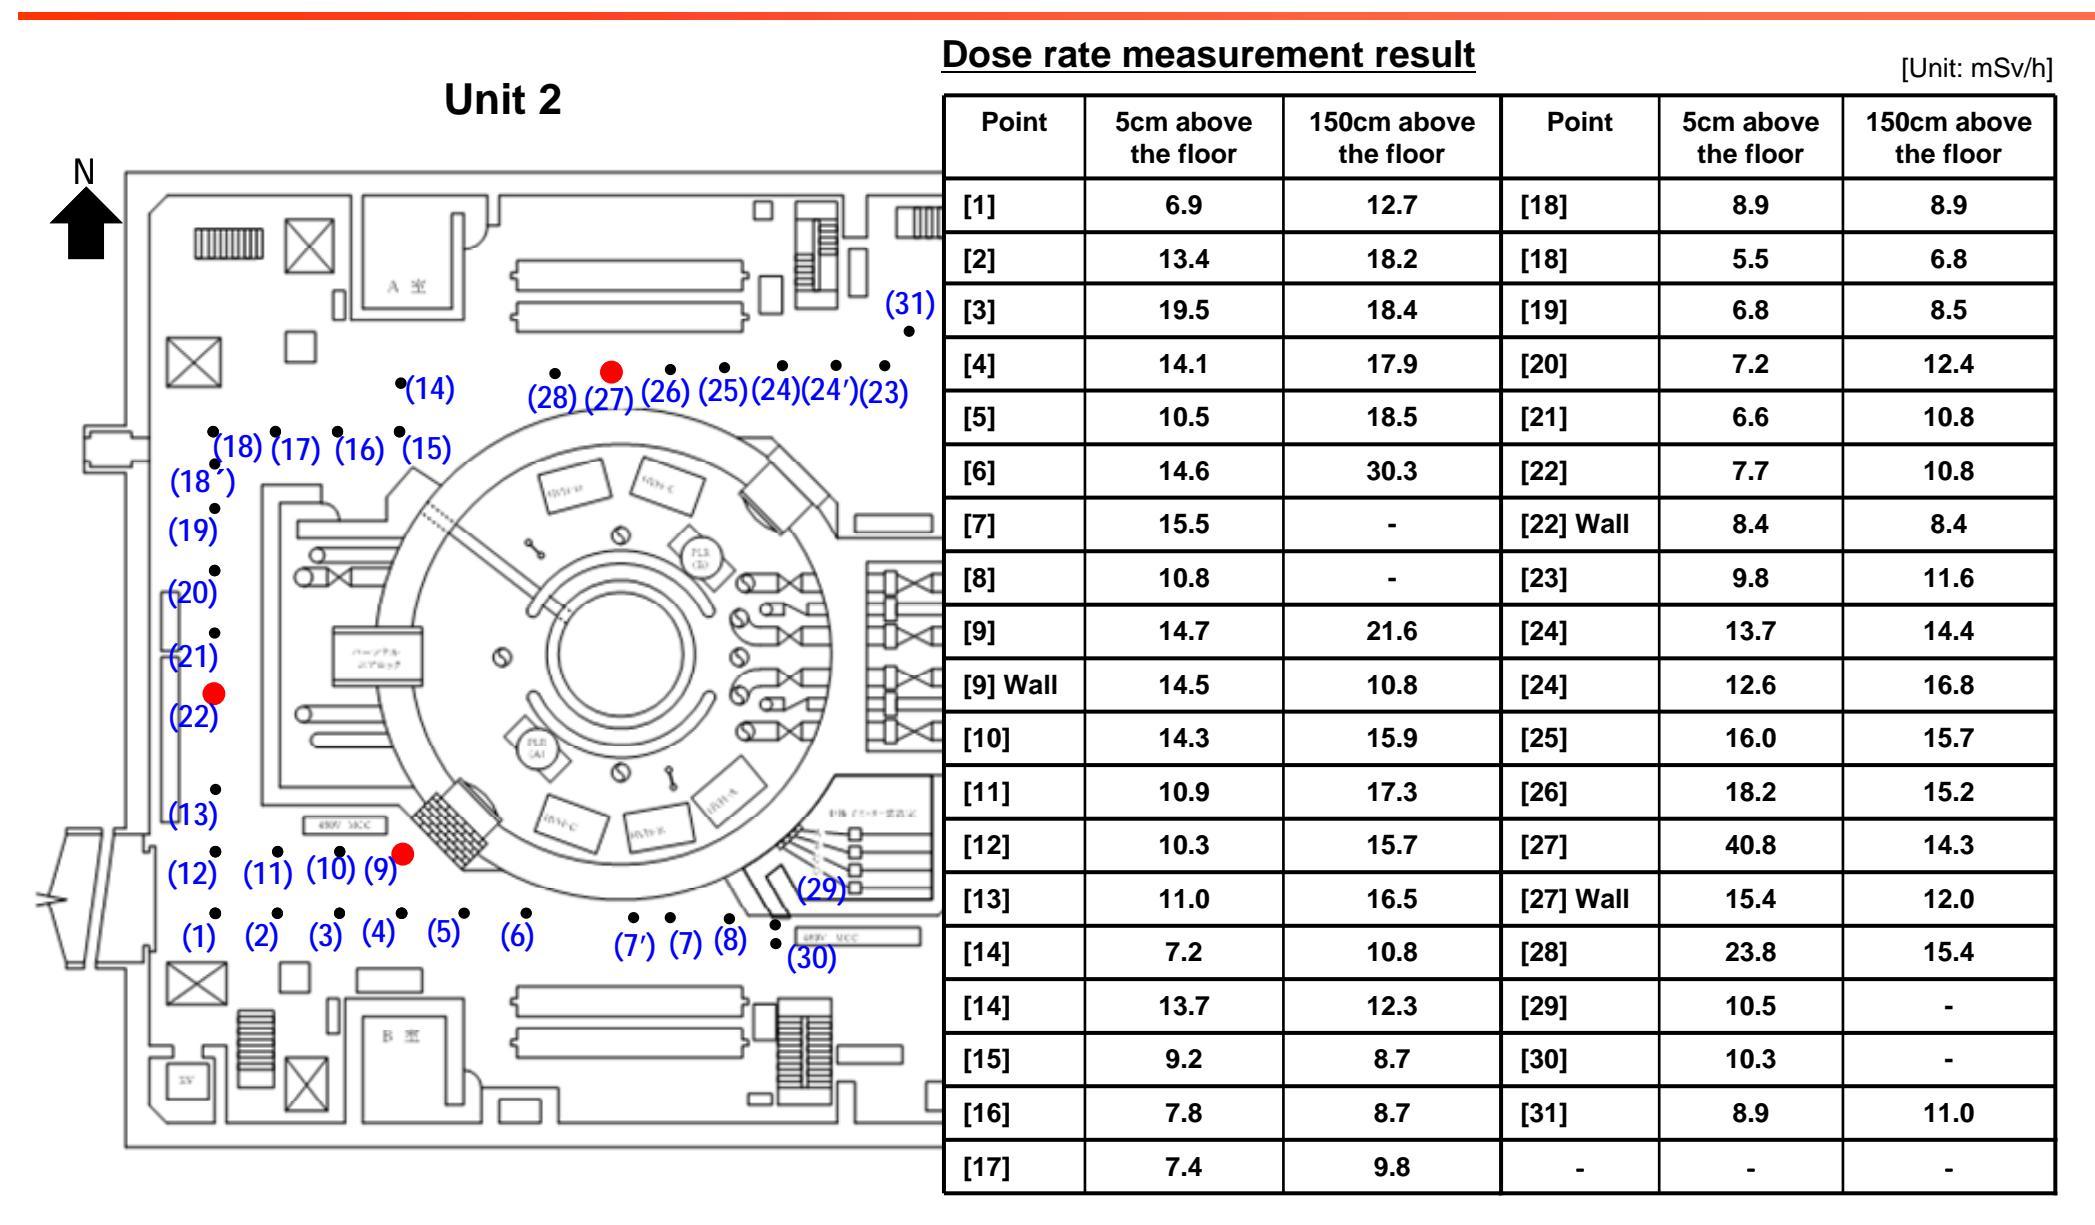
Dose Rate Measurement Result: Unit 2 Reactor Building 1st Floor

-No significant difference in the dose rate distribution among different areas (Range: 10-20mSv/h). -As is the case with Unit 1, the dose was higher at 150cm from the floor compared to 5cm from the floor. Assumed cause: the nuclides included in the steam that leaked from PCV are attached on the floor, walls and ceiling as there was no hydrogen explosion at Unit 2.

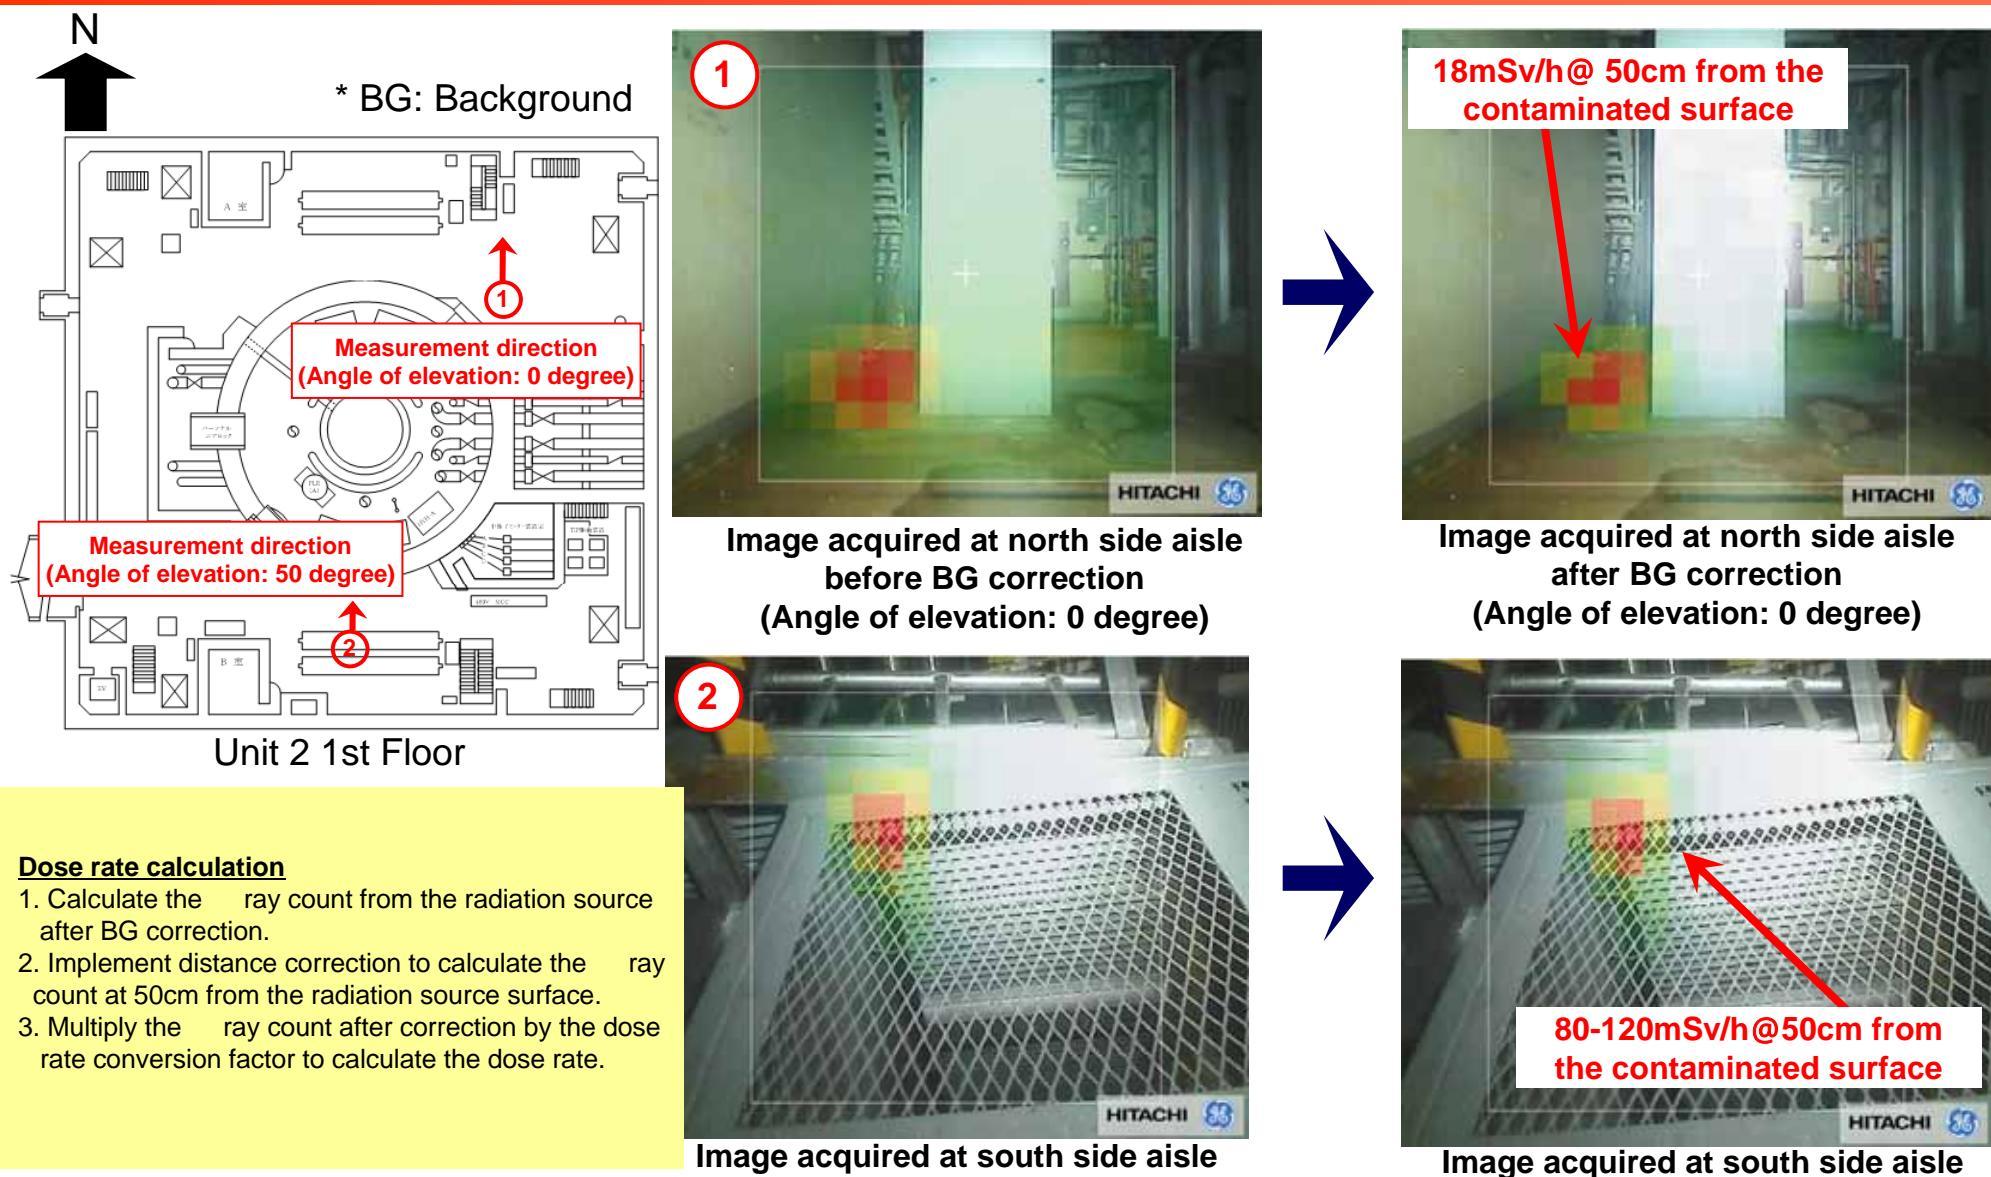
Gamma Camera Images (Example): Unit 2 Reactor Building 1st Floor 5

before BG correction (Angle of elevation: 50 degree)

after BG correction

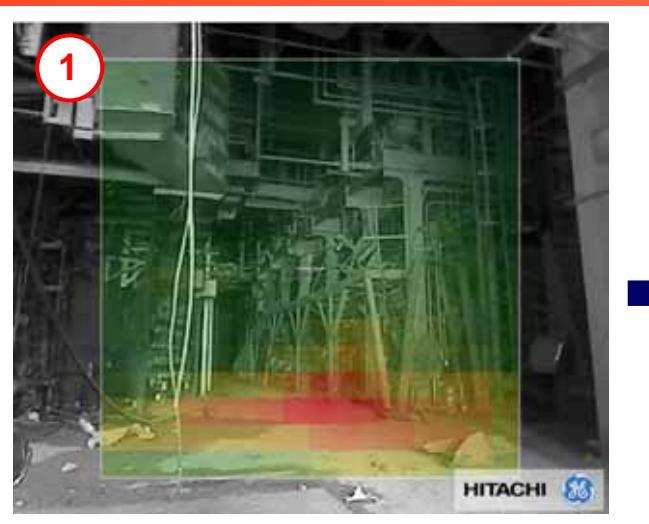
Image acquired at the large carry-in entrance in before BG correction (Angle of elevation: 10 degrees)

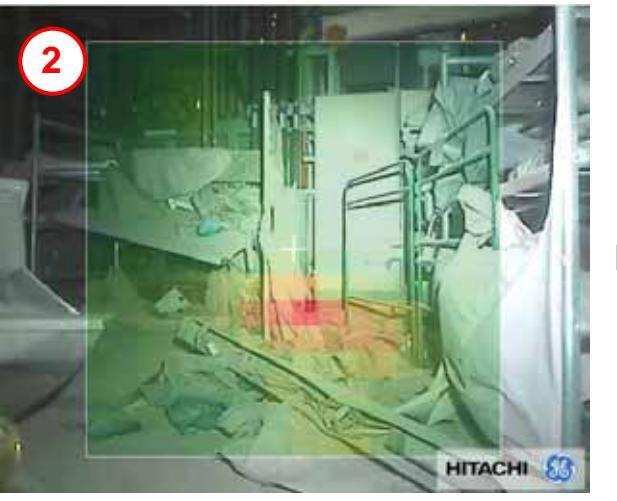
Image acquired at the northwest corner before BG correction (Angle of elevation: 0 degrees)

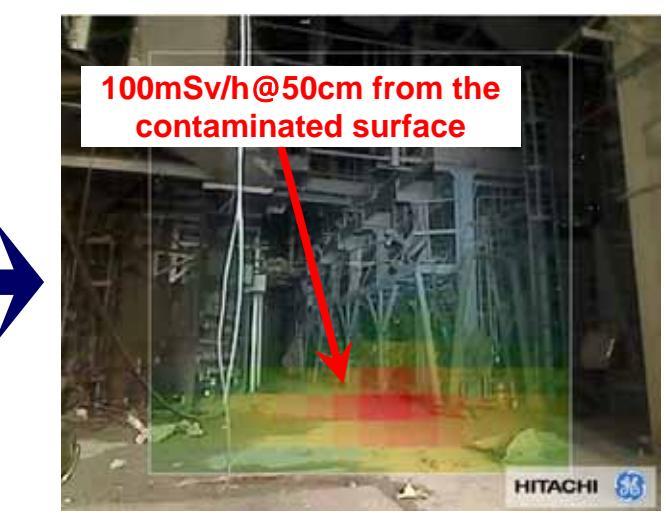
Image acquired at the large carry-in entrance after BG correction (Angle of elevation: 10 degrees)

-At Unit 3, the areas where debris and dust are accumulated are radiation hot spots.

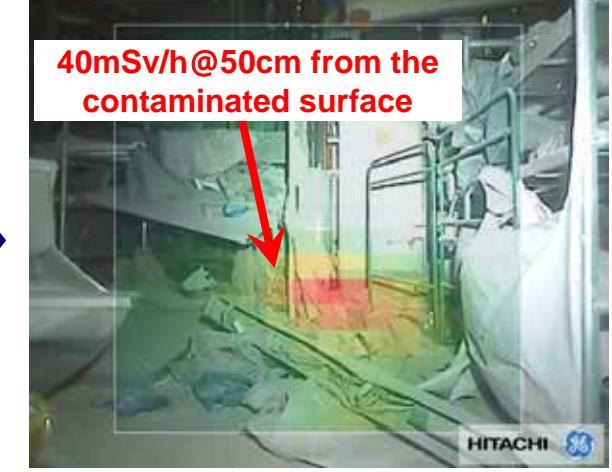
Image acquired at the northwest corner after BG correction (Angle of elevation: 0 degrees)

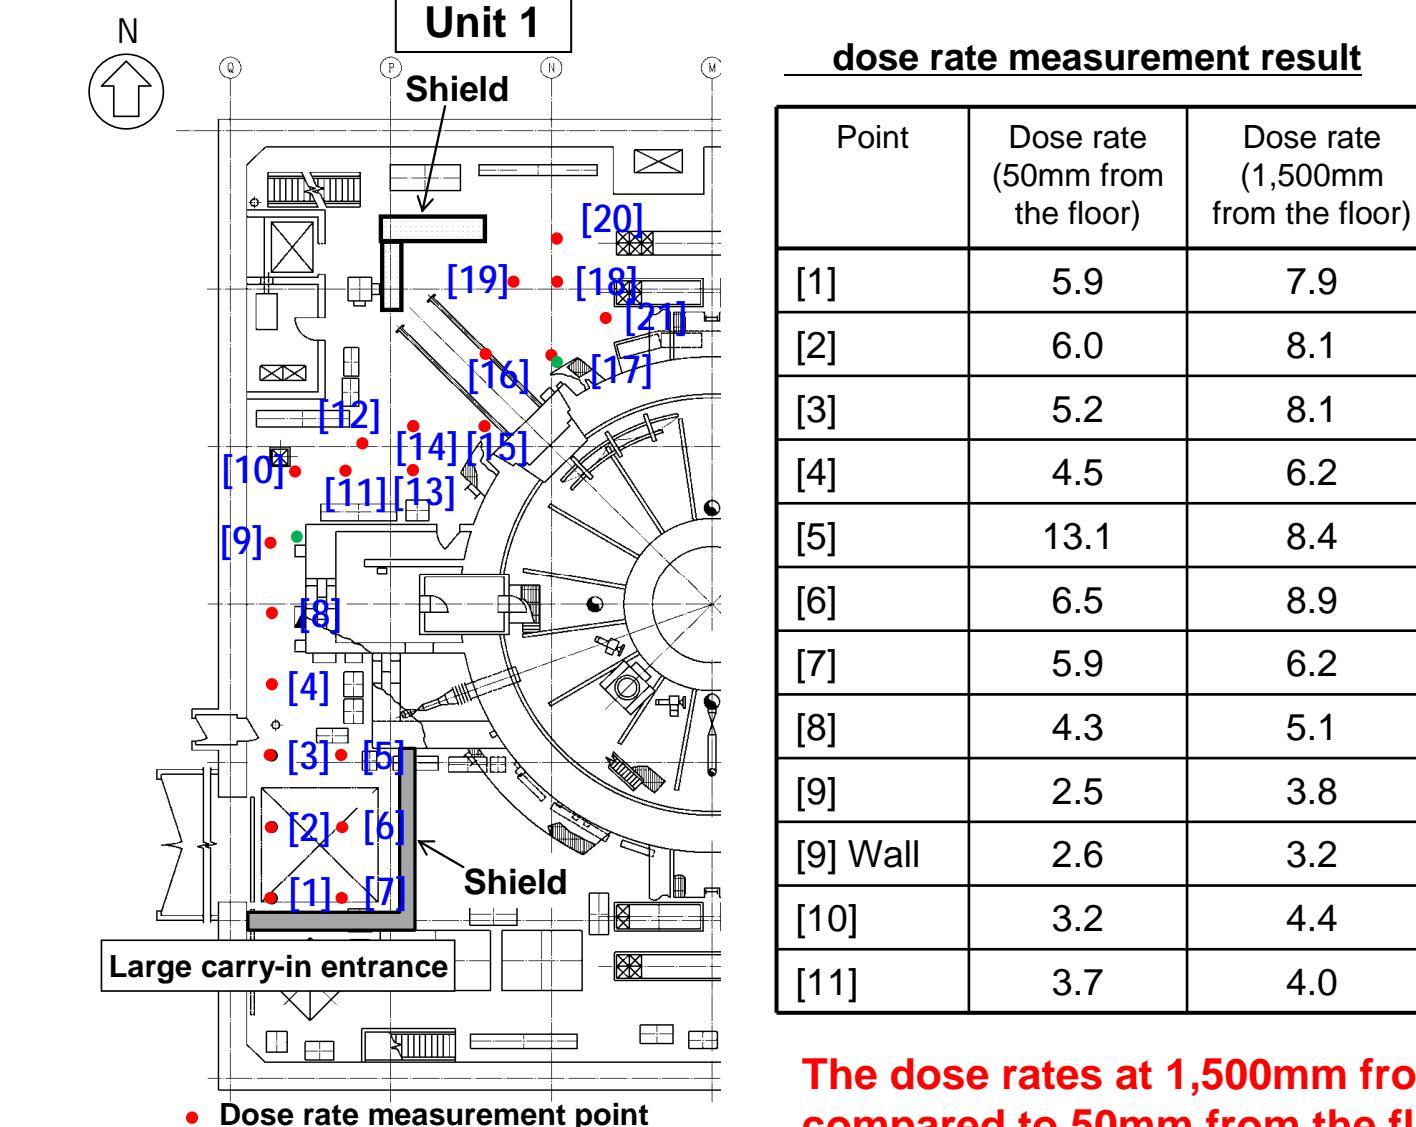
[Reference] Dose Rate Measurement Result: Unit 1 Reactor Building 1st Floor

The dose rates at 1,500mm from the floor are slightly higher compared to 50mm from the floor.
